Manhole Inspection Summary

Manhole # S11AA2013MH

Location Address: **2410 BRIARWOOD RD** Cross Street: **ROCKSPRING RD**

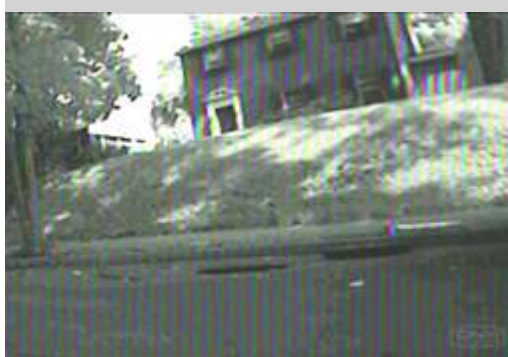
Location View

Comments **Cracks in pavement around manhole. Possible source of infiltration.**

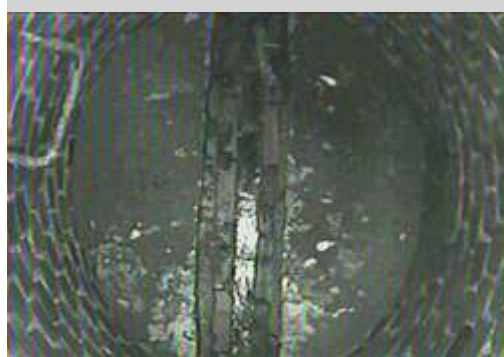
Top View

Steps Count: **3** Missing: **0** ☒ **Corroded**

Surcharge ☒ **Evidence Of Surcharge** Depth: **1** (ft.) ☐ Active Surcharge Present

Evidence of surcharge - Bench debris.
Corroded steps.

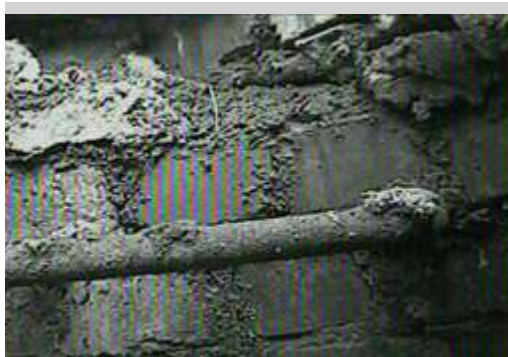
Defect

Corbel Material: **Brick** ☐ Parged Type: **Concentric/Eccentric**
Condition: ☒ Sound ☐ Cracked ☐ Root Intrusion ☐ Loose Brick ☐ Deteriorated
Infiltration: ☐ None ☐ Joint ☐ Cracks ☒ **Mortar** ☐ Roots ☒ **Wall**

Corbel infiltration.

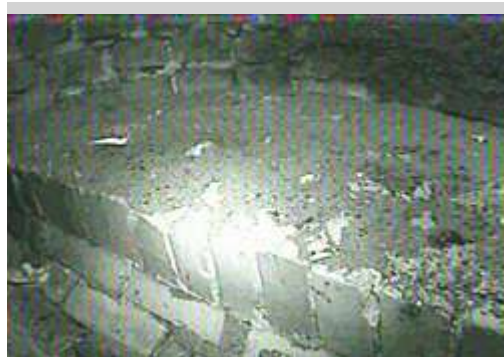
Defect

Barrel Material: **Brick** ☐ Parged
Shape: **Circular** Diameter: **48** (in.) Length: (in.)
Condition: ☐ Sound ☐ Cracked ☐ Root Intrusion ☐ Loose Brick ☒ **Deteriorated**
Infiltration: ☐ None ☐ Joint ☐ Cracks ☒ **Mortar** ☐ Roots ☒ **Wall**

Barrel deterioration and infiltration. Bench debris.

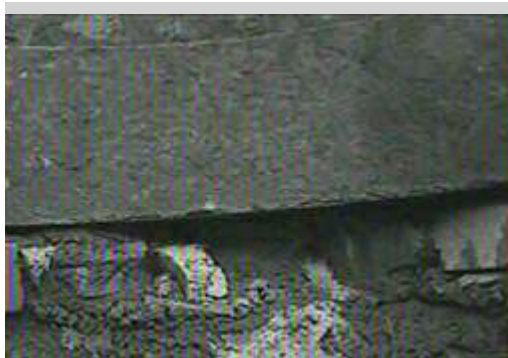
Defect

Frame Offset: **0** (in.) Condition: ☐ Sound ☐ Cracked ☒ **Leaks**

Chimney / Frame Adjustment ☒ Exists Material: **Brick** ☐ Parged Height: **6** (in.)
Condition: ☐ Sound ☐ Cracked ☐ Root Intrusion ☐ Loose Brick ☒ **Deteriorated**
Infiltration: ☐ None ☒ **Joint** ☐ Cracks ☒ **Mortar** ☐ Roots ☐ Wall

Frame leaks. Adjustment deterioration
and infiltration.

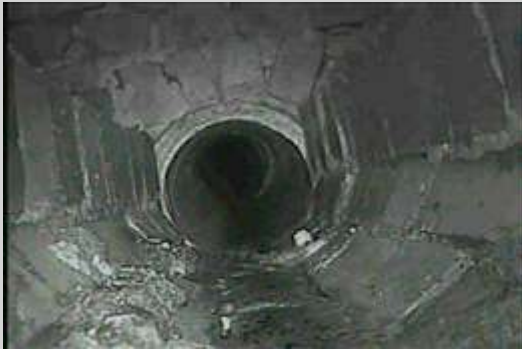
8 in. Circular Gravity Sewer Pipe Out @ 12 O'Clock

Infiltration: **Evidence** Pipe Seal Cond: **Unknown**
